Marine Accident Brief

Accident No.: DCA01MM015

Vessel: U.S. Passenger Ferry *FINEST*, O.N. 1044082, 93 gross tons, overall length 127 feet, beam 32.8 feet, draft 6 feet, catamaran (aluminum) hull, built in 1996; inspected

Accident Type: Grounding

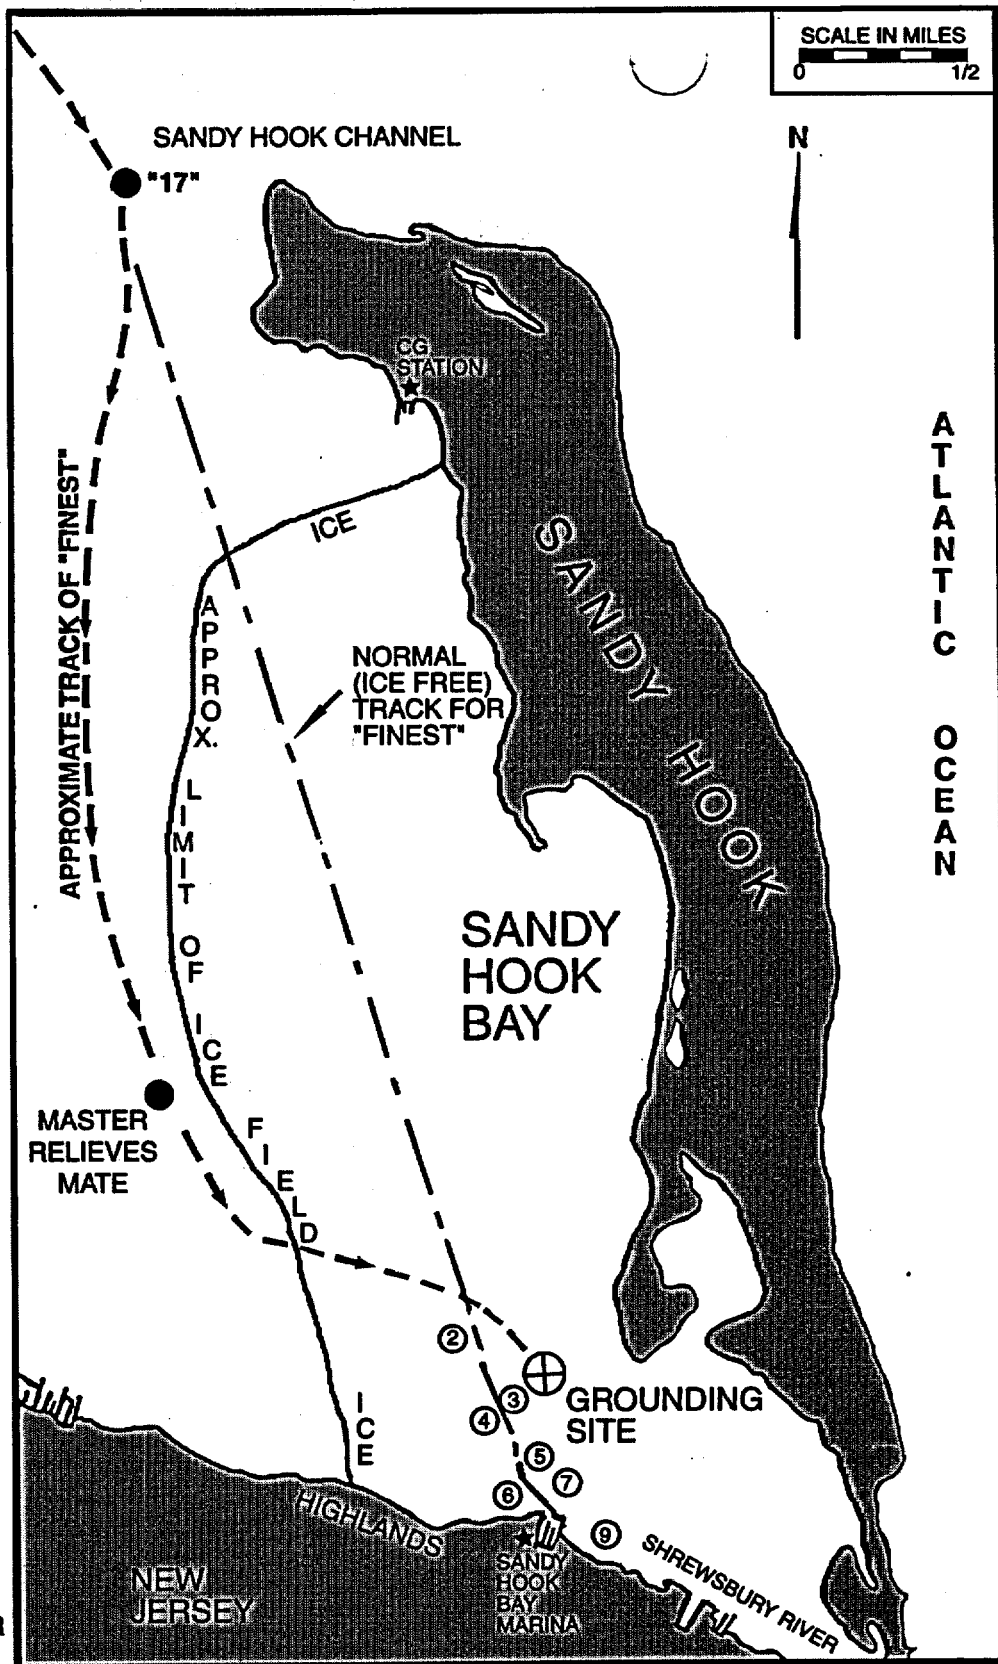
FIGURE 1B. ACCIDENT SITE

5 As the *Finest* passed Buoy 17 in the Sandy Hook Channel, about ½ mile west of the
6 northern end of Sandy Hook, ice was observed inside of Sandy Hook and covered the normal
7 track the vessel would take to the Shrewsbury Channel and the SHBM (about 3 ½ and 4 miles,
8 respectively; see figure 1B). The mate altered course to parallel, on a southerly course, the
9 western edge of the ice field. The master took over the conn about 2 ½ miles later, continuing
10 southbound with the *Finest* still outside of the ice. About ½ mile later, with the *Finest* about 7/10
11 mile from the southern shore, the master turned the vessel to port, in an easterly direction and
12 toward the ice field. The vessel's engines were slowed as the *Finest* entered the ice. The
13 electrical generators could not pump cooling water to its system in the ice and was secured to
14 prevent overheating damage. Without the generators operating, the PA system and the HVAC

17 The buoys of the Shrewsbury Channel were not seen. The mate was sent outside on the
18 starboard bridge wing, but still could not see the buoys. Also, the master could not see the buoys
19 on the radar screen. The buoys had been forced under the ice by the outgoing (ebb) tide, which is
20 not an uncommon situation with ice present in the bay. There was no range¹ for the Shrewsbury
21 Channel and the master did not use the chart plotter or use the radar to take ranges or bearings for
